Westshore Beach: Regrading, Napier

Westshore Beach: Regrading

Prepared for
Napier City Council

By
Beca Infrastructure Ltd

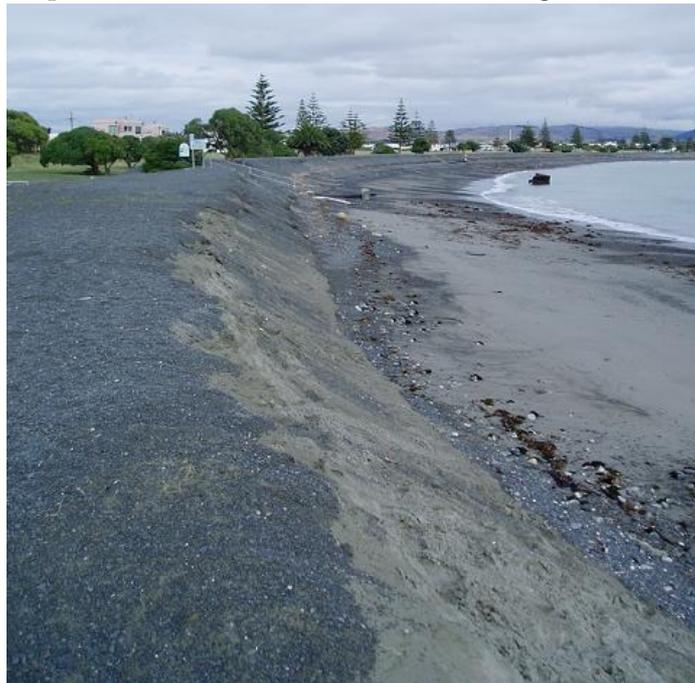
Photo 1

- Pacific Beach has a flatter beach slope due to the higher wave exposure and due to its accretional state.
- Westshore Beach is exposed to a lesser amount of wave energy than Pacific Beach. This results in more sand within the mixed sand and gravel system and a steeper overall beach slope that is also the result of its continuing erosional state. See Photo 1.

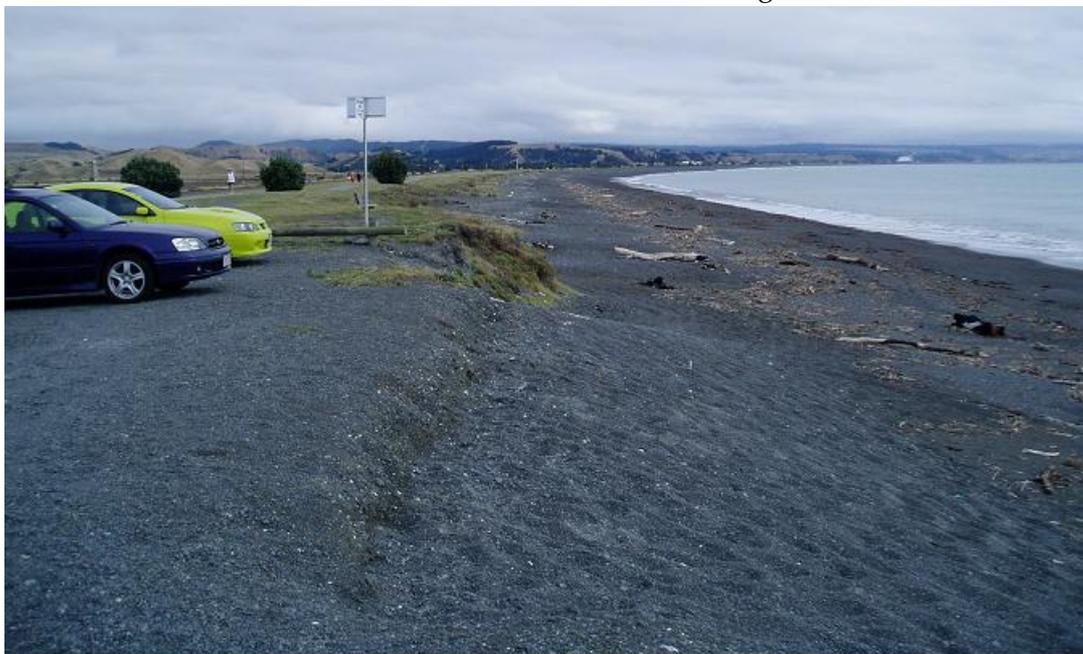
Photo 2

- As Westshore Beach is exposed to more wave energy (from south to north) the beach crest becomes flatter, the sediment coarser and the crest higher. See Photo 2.

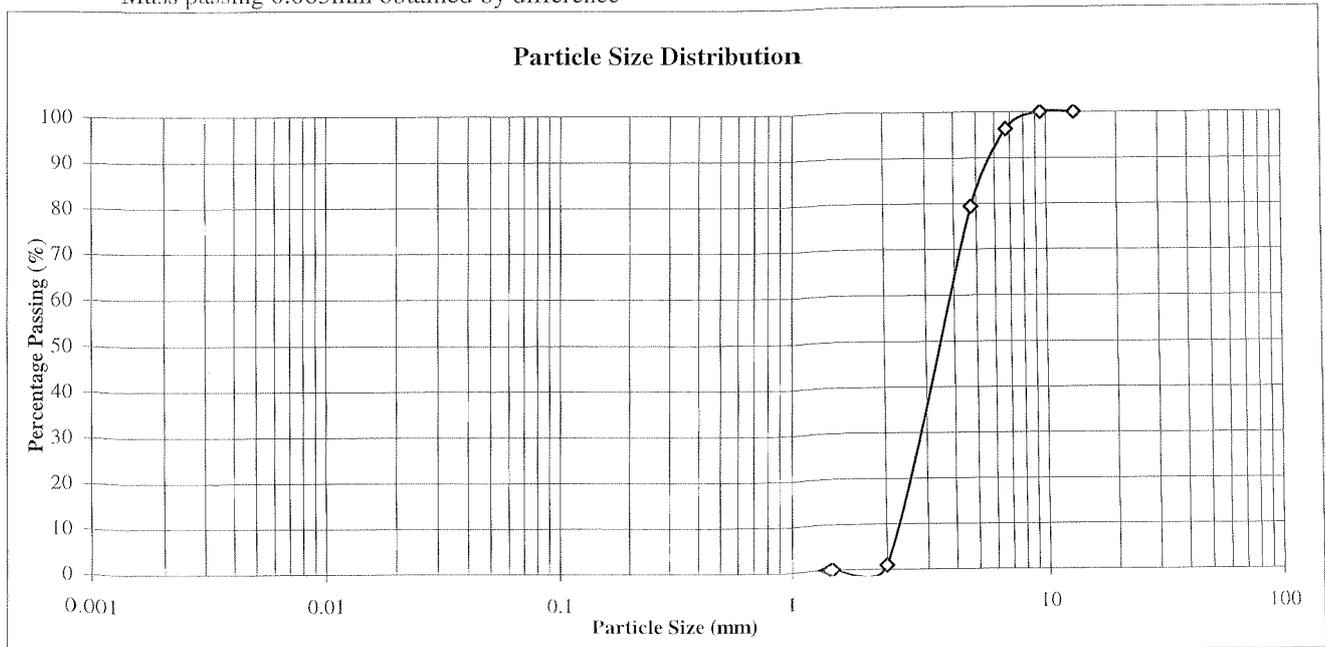
Coarse & Intermediate Fraction		Fine Fraction	
Sieve Size	% Passing	Sieve Size	% Passing
75mm	100	2mm	1
63mm	100	1.18mm	0
53mm	100	600µm	0
37.5mm	100	425µm	0
26.5mm	100	300µm	0
19mm	100	212µm	0
13.2mm	100	150µm	0
9.5mm	100	90µm	0
6.7mm	96	63µm	0
4.75mm	79	<63µm*	0
